# USP Quality Review

## Too Much Similarity

The following error descriptions and recommendations are summarized from reports received through the USP Medication Errors Reporting (MER) Program during the time period July—September 2003. These cases illustrate how the similarity in product labeling and packaging and the drug product itself can lead to errors or have a potential to cause errors. When reading these examples, it may be apparent to the reader that the products differ; but in a busy work environment where there can be many distractions, it is easy to mistake these products for one another.

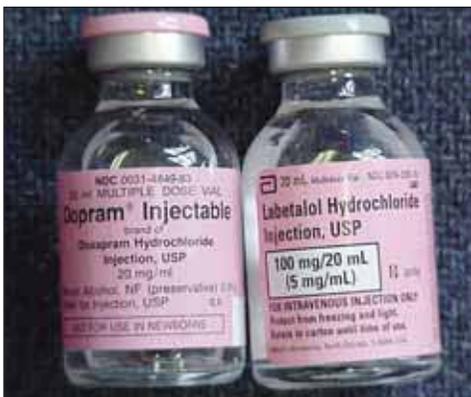
The facility ran out of labetalol, which required them to purchase some from a neighboring hospital. The neighboring hospital carried a different brand of labetalol (manufactured by Abbott) than the facility normally stocked. The facility realized that the labeling of the Abbott brand of labetalol looked similar to A.H. Robins' Dopram® when the vials were placed next to each other on an anesthesia cart. Dopram is indicated for respiratory depression and labetalol is for hypertension.

Photo of Dopram and labetalol similar labeling/packaging\*

**Reporting pharmacist's action/recommendation:** To prevent this potential error from occurring, the facility removed the look-alike labetalol and replaced it with the brand they usually purchase.

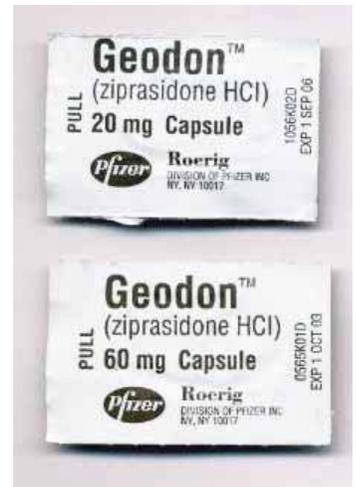
The labeling of Geodon™ (manufactured by Pfizer) 20 mg and 60 mg tablets is similar. The pharmacist was verifying an order for a total dose of 80 mg. The order was filled with a 20 mg and 60 mg tablet, and had a sticker attached that read, “note the dose” to indicate that both tablets should be administered. At first glance, the pharmacist believed the order was filled wrong and that they were both 60 mg tablets.

Photo of Geodon 20 mg and 60 mg similar unit-dose packaging\*

**action/recommendation:** The facility took several actions to avert mix-ups: The pharmacist (1) notified staff, (2) initiated use of cautionary stickers on the unit-dose package, (3) added a warning in the computer system, and (4) separated the two products on the shelves.

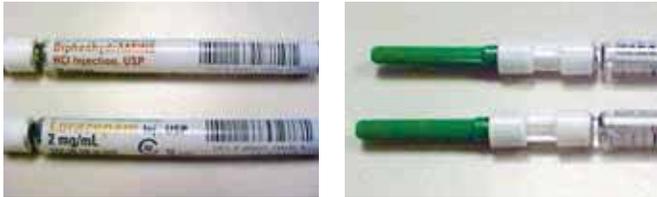
A pharmacy technician noticed that a lorazepam Carpuject® (for anxiety disorders) was returned to the pharmacy and placed in the diphenhydramine (for allergic symptoms) bin. Both products are manufactured by Abbott. Upon

further investigation, it was realized that the Carpujects have green caps and look very similar to each other.

Photos of diphenhydramine and lorazepam similar Carpuject packaging\*

**Reporting pharmacist's action/recommendation:** The manufacturer should consider changing the color of the caps on the Carpujects® as well as changing to a different color for the drug name.

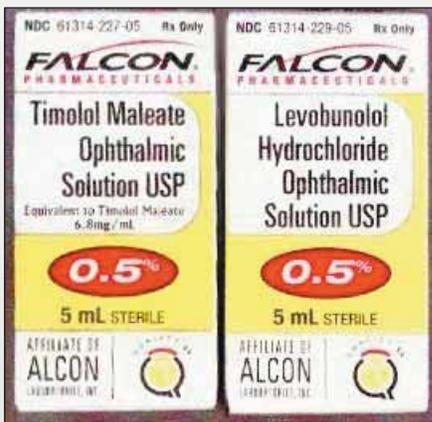
Falcon Pharmaceuticals timolol 0.5% and levobunolol 0.5% ophthalmic solutions (both used for the treatment of intraocular pressure) have very similar packaging and were found in the same location on the pharmacy shelf. The label, dose, size, and even color of the boxes are nearly identical. Both products were received from the wholesaler on the same day. It is believed that a technician assumed they were the same product and placed them together on the shelf; the levobunolol's normal location is on a separate shelf. The pharmacist caught the error when one product was being labeled for dispensing.

Photo of timolol and levobunolol similar labeling/packaging\*

**Reporting pharmacist's action/recommendation:** The facility has purchased a different brand of levobunolol to avoid future mix-ups.

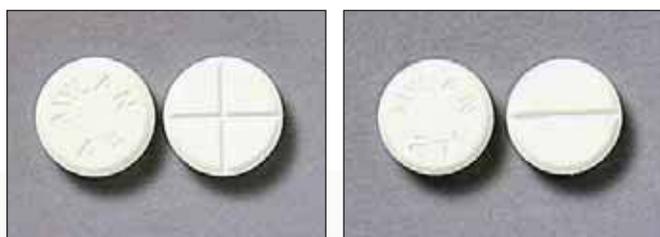
A patient was prescribed diazepam 2 mg, but received alprazolam 2 mg (both are used to treat anxiety disorders). The bottle the patient received was labeled as diazepam 2 mg. The patient felt tired and dizzy and contacted the physician. Staffing at the pharmacy was adequate. The possible cause of this error was the similarity in the tablets' shape, color, and markings (both are manufactured by Mylan Pharmaceuticals).

alprazolam 2 mg

diazepam 2 mg

Photos of similar tablets†

Technicians must check the NDC before counting tablets; drugs with potential for error are distinguished by red dividers; drugs with no image in the computer are placed with the original prescription.

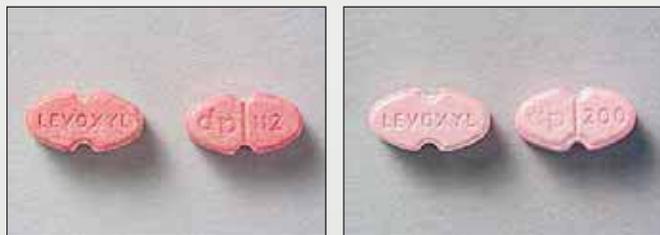
The wrong strength, 0.112 mg vs. 0.2 mg, of Levoxyl® (manufactured by Jones Pharma, Inc.) was dispensed to the patient. The tablets are the same color, size, and shape, and the bottles are identical except for the strength.

Levoxyl 0.112 mg

Levoxyl 0.2 mg

Photos of similar tablets†

**Reporting pharmacist's action/recommendation:** The two strengths are now placed in different areas of the pharmacy. The color of the bottle and tablets should be changed.

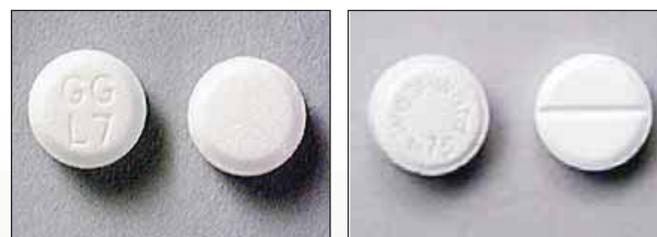
Atenolol 25 mg (for hypertension), by Geneva Pharmaceuticals, and prednisone 5 mg (a corticosteroid), by West-Ward Pharmaceuticals, were packaged by a

technician. The wrong prescription labels were placed on the blister cards by the technician and the stock bottles were left with the cards to be checked by the pharmacist. The error was not caught by the pharmacist, as the tablets are very similar in size, shape, and color. The nurse administering the medications to the patients caught the error.

atenolol 25 mg

prednisone 5 mg

Photos of similar tablets†

**Reporting pharmacist's action/recommendation:** All drugs should be double-checked with the original stock bottles by the pharmacist. The original containers should be opened and the tablets should be examined closely (i.e., with a magnifying glass if necessary) to ensure that the appropriate product is being dispensed.
